HOW TRAVELING WAVE TECHNOLOGY IS LOCATING THE FAULT SITE

Investigation of Fault Activity on a 132KV Teed Circuit in Scotland

THE SLOY, WINDYHILL, DUNOON TEED CIRCUIT.

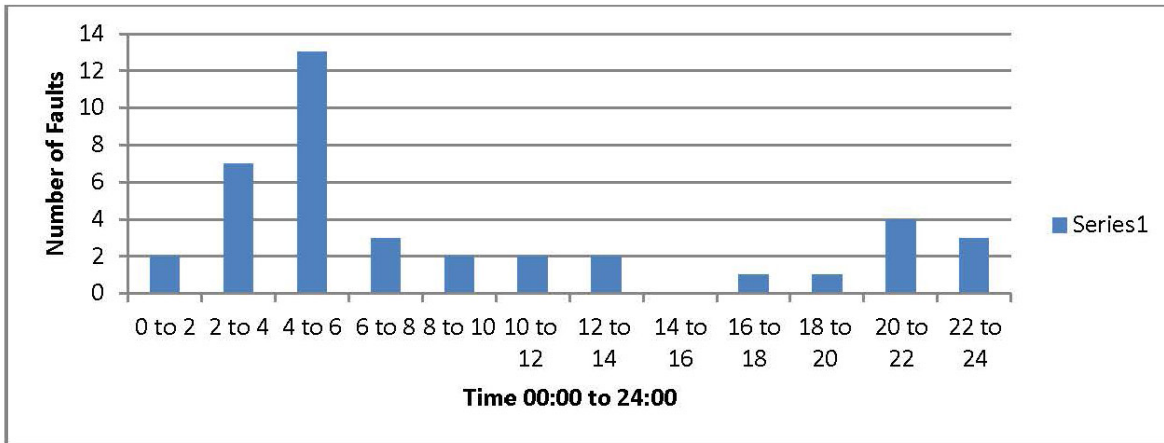
Fig 3 Distribution of Faults by Time of Day

Figure 3 shows the distribution of faults of GL1 and GL2 by time of day. The distribution on both circuits is similar and it can be seen that more occur during the night particularly between 4am and 6am in the morning.

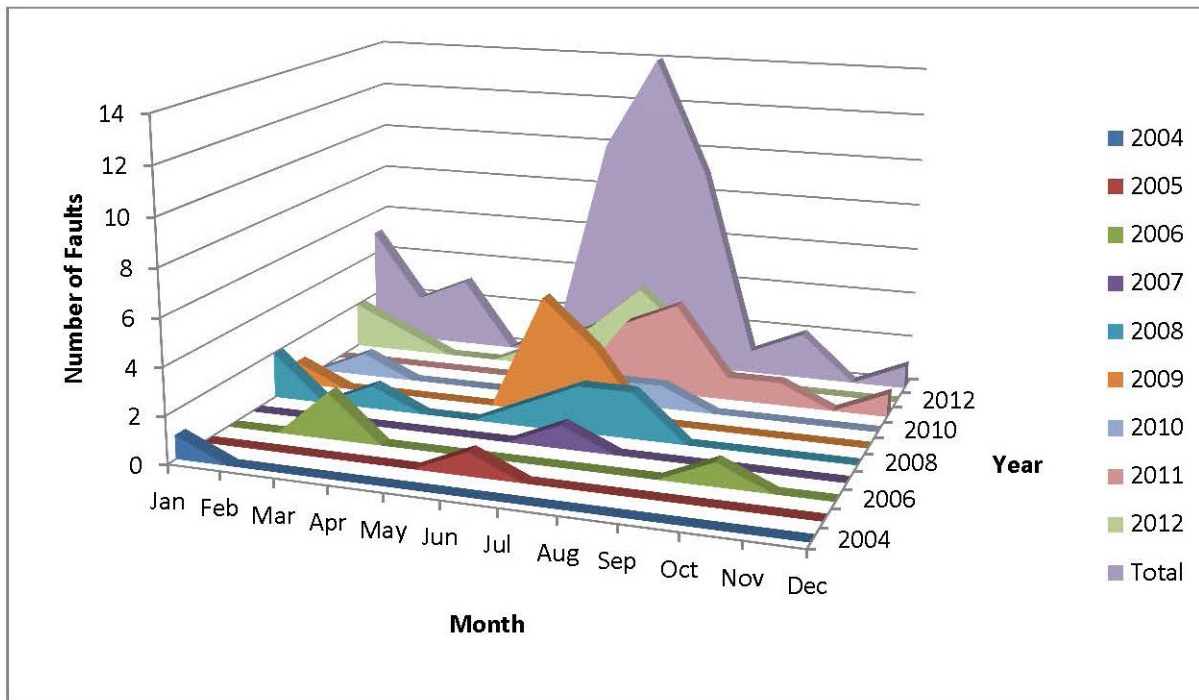
Fig 4 Distribution of Faults by Time of Year

Figure 4 shows the distribution of faults by time of year. It can be seen that most occur between June and September with the number rising annually.

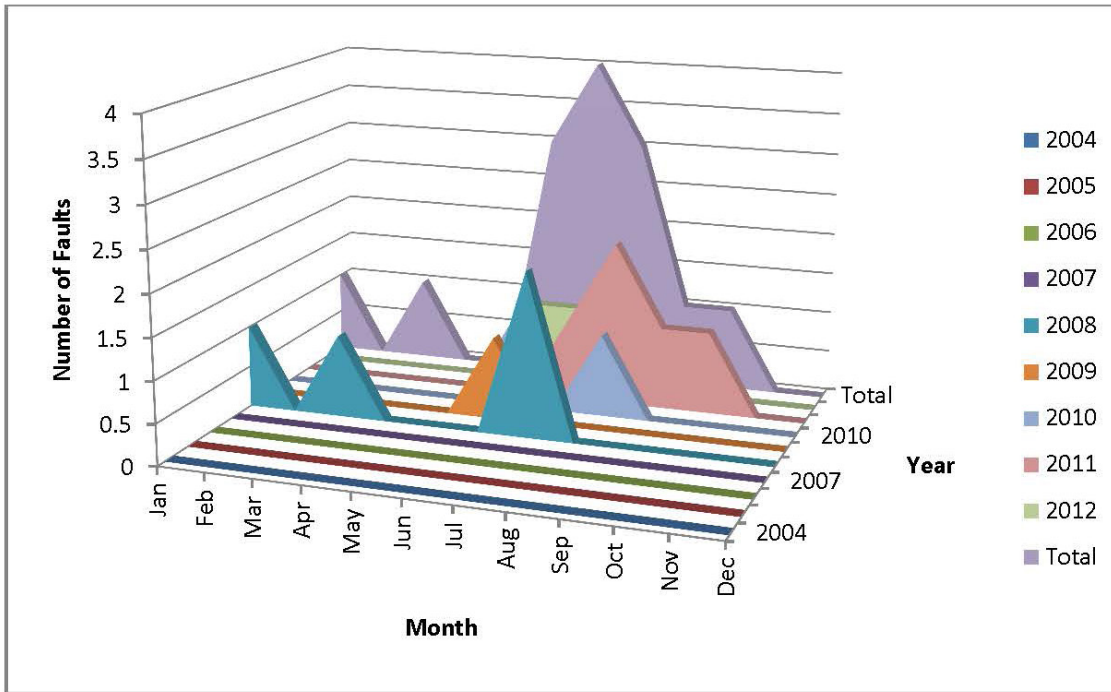
Fig 5 Distribution of Faults on GL1 Top Phase

The last analysis examined which phases were involved in the faults. Again the distribution on the two circuits was similar. Only the faults from GL1 are shown. Figure 5 is the distribution of faults affecting the top red phase and figure 6 the distribution of faults on the middle yellow phase.

Most faults occurred on the top phase with about 50% on the middle phase and very few on the lower phase. In the analysis SSE considered the following:

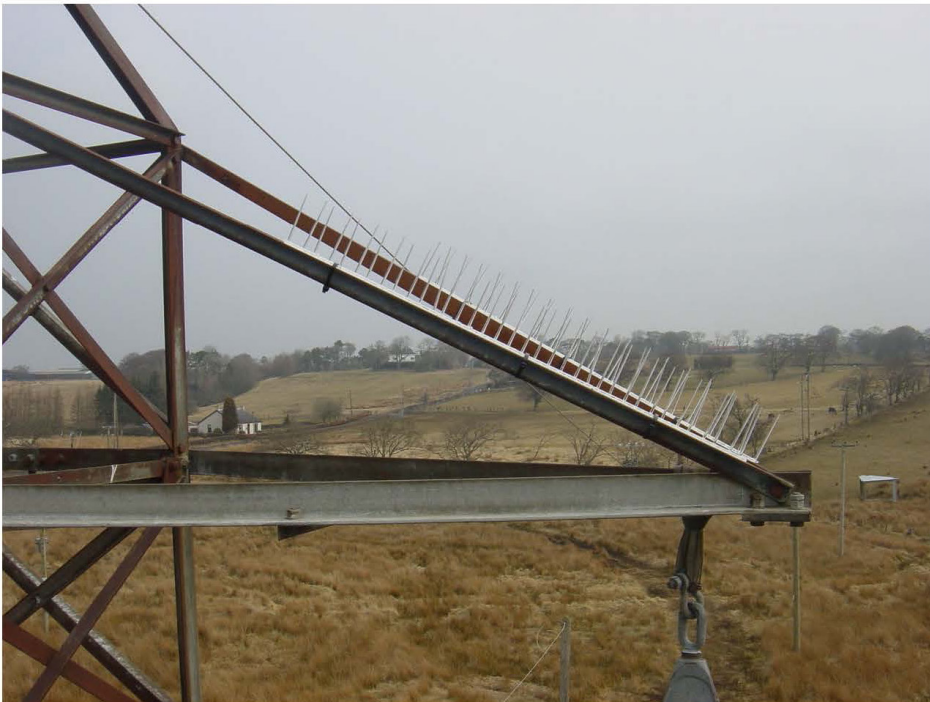
Fig 7 Bird Deflectors Fitted to a Tower near the Landfill Site

There is some evidence to indicate that birds are no longer roosting on the towers as a result of the deflectors but there is a suggestion that the bird deflectors have captured some wind borne debris. On balance the results of installing bird deflectors since March 2013 to date have been more positive than negative. Since completion of the above work the number of line trips with unknown causes has decreased significantly but further time is needed to confirm that this is due to the remedial works.

- In 2013 it was decided to install bird deflectors on 7 towers close to the landfill area. This was a difficult decision as although birds were considered a probable cause of faults at the landfill site the spikes on the deflectors can snag windblown debris, especially plastic bags, and cause other problems.
- In 2013 it was decided to add voltage sensors to test taps on the HV bushings of the transformers at Dunoon to implement double ended traveling wave fault location that extended down the tee when combined with results from existing units at Sloy and / or Windyhill.
- The condition of the conductors was assessed to be good from SSE records and this was confirmed in 2014 by on site measurements. This supported the decision not to replace the conductors.

After planning and budgeting the above work was completed in phases during 2013 and 2014. Figure 7 shows a tower fitted with bird deflectors.

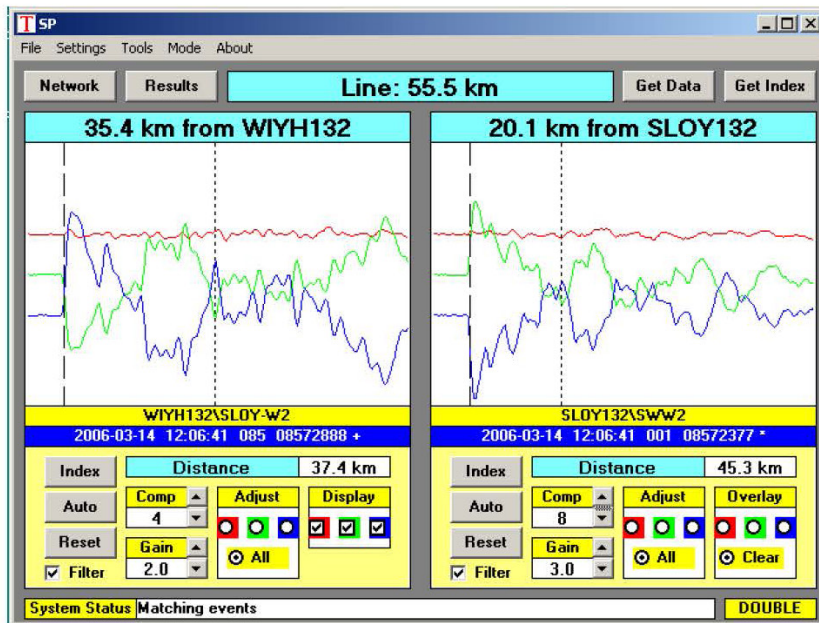
Fig 8 Travelling Wave Result for Phase to phase fault in March 2006

The TW waveforms indicate a phase to phase fault confirmed by the fault recorder trace from Windyhill for the same incident shown in Fig 9. The lack of accurate fault location on the Dunoon tee was a major hindrance in establishing root cause of the line trips and proved very costly in helicopter use 6,000 GBP per day and extended foot patrols costing hundreds of pounds.

Corrected result is 19.38Km from Sloy and 34.5KM from Windyhill when a corrected line length of 53.9Km is used

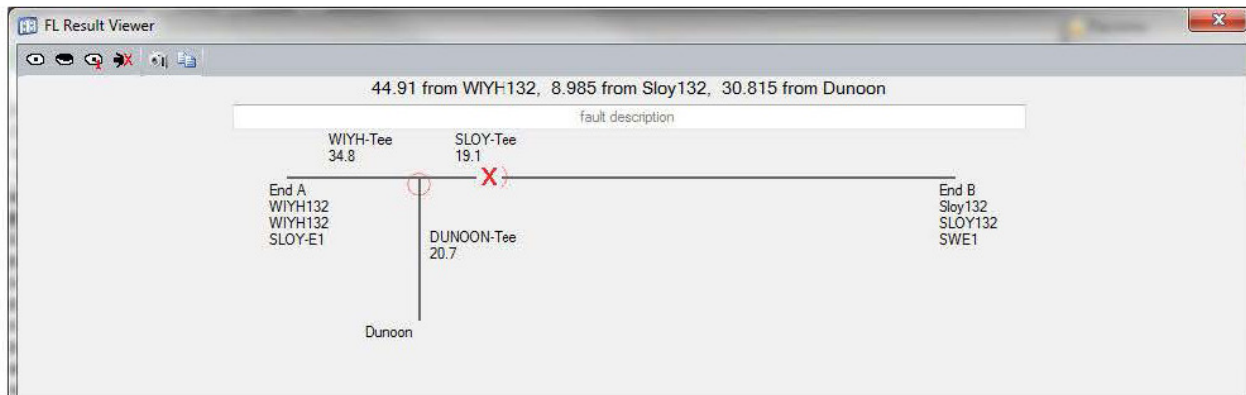
Fig 12 Results from Trip on 5th December 2013

The bushing couplers fitted to the transformers at Dunoon are proving to be a good signal source for traveling waves meaning there is now full three ended coverage of the tee'd circuit. The first trip after commissioning was on 5th December 2013 on the GL1 circuit and was located 9Km from Sloy on the main line. Figure 12 shows the graphical result from the analysis software. In this view all the different 2 ended possible results are marked with the X showing the actual fault position.

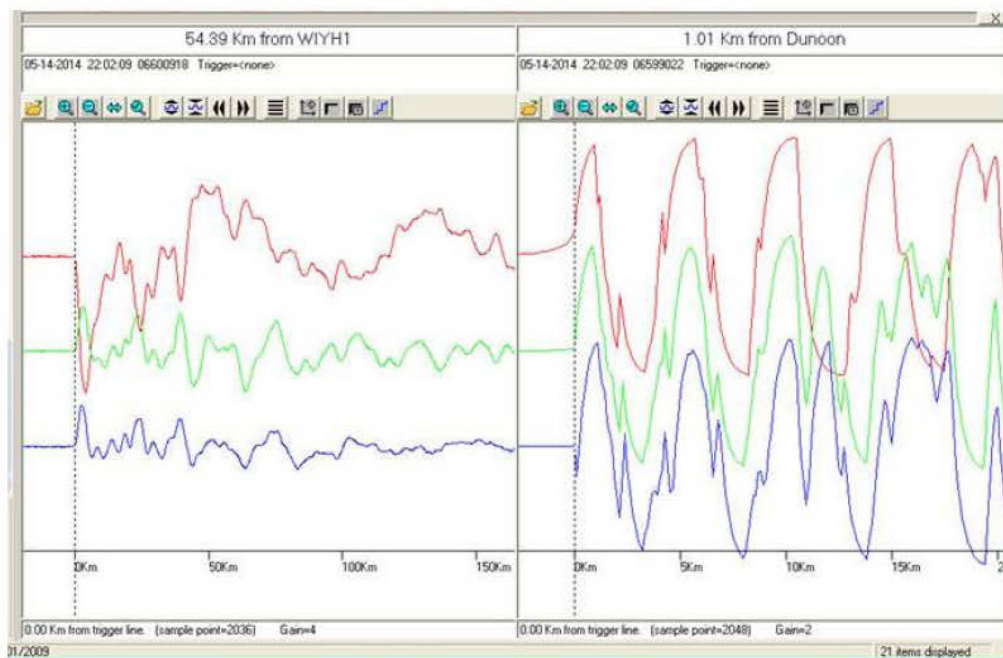
Fig 13 Fault Location from on 14th May 2014

Two other trips occurred in 2014 both of which were on the Dunoon tee section and both of unknown origin. The first was on the 14th May at 23.02. It occurred on the top phase (red) of the GL1 circuit and the TW system located the fault at 1Km from Dunoon as shown in the double ended measurement from Windyhill to Dunoon in Fig 13.

Note that the time shown is 1 hour early as the daylight saving function was not enabled

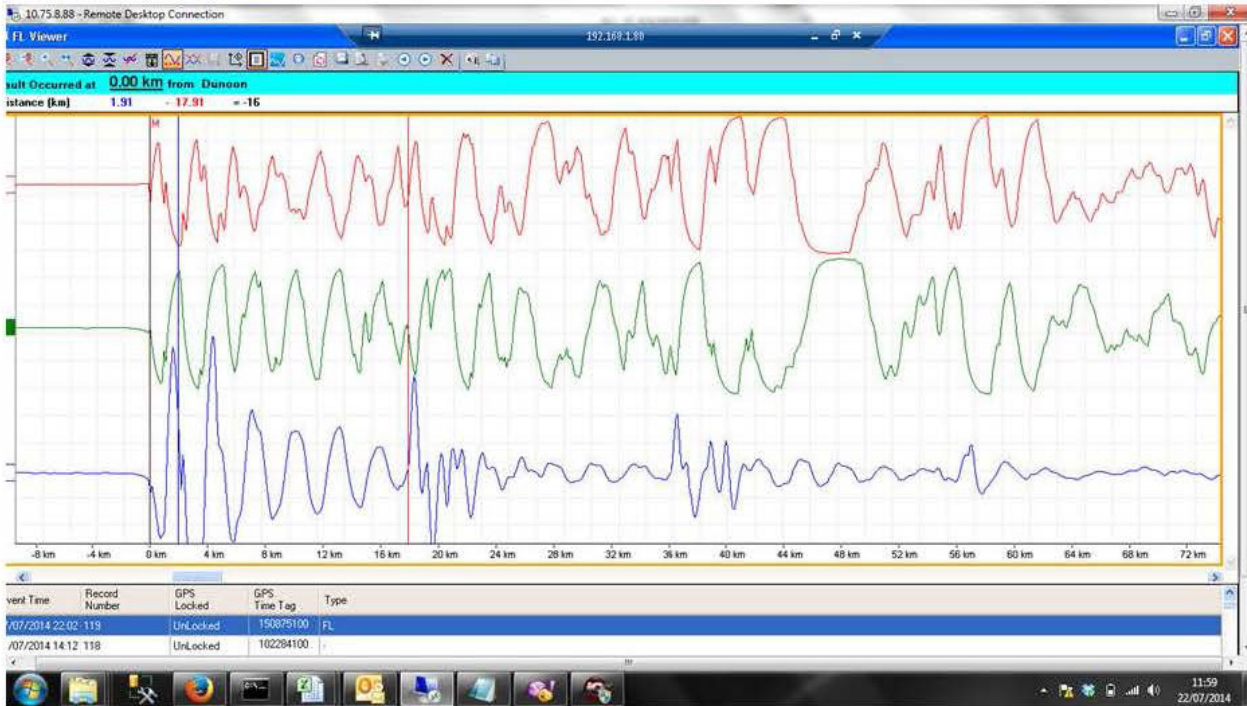
The second fault occurred on the 17th July at 23.02 on the top phase (blue) of the GL2 circuit. The Windyhill section of the circuit was out of service for maintenance and the TW device at Sloy had been taken off line meaning only a manual single ended analysis of fault location was possible from Dunoon. The single ended manual analysis puts the fault close to Dunoon, less than 2Km. The clear reflection of opposite polarity that can be identified (where the red vertical cursor is placed) is 17.91Km out. If the fault was high impedance then this could be the reflection of the fault generated transient from Whistlefield meaning 17.91Km is the distance back from Whistlefield. This would place the fault about 1Km from Dunoon.

Both faults were in the same vicinity just outside the area protected by the bird deflectors and work is now concentrated in this small area to try to identify the cause. The occurrence of the faults at the same time is also interesting.
