HOW TRAVELING WAVE TECHNOLOGY IS LOCATING THE FAULT SITE

Investigation of Fault Activity on a 132KV Teed Circuit in Scotland

THE SLOY, WINDYHILL, DUNOON TEED CIRCUIT.

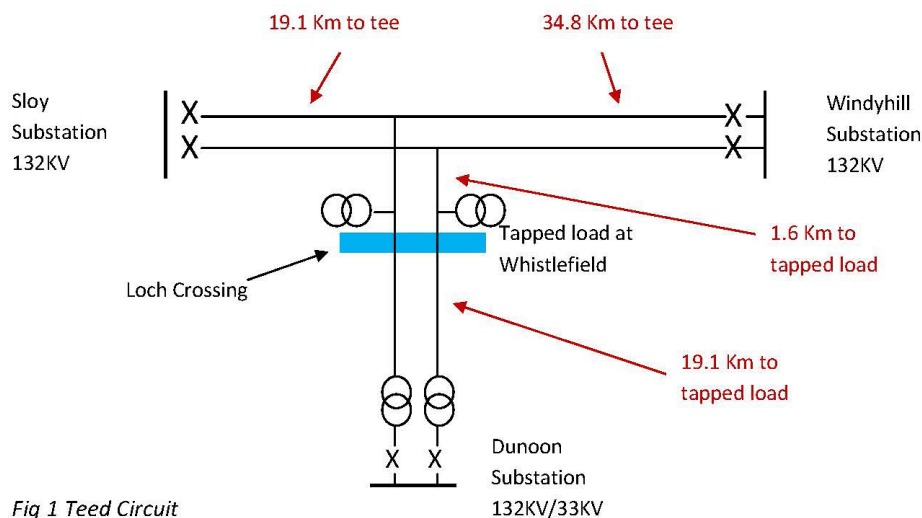
Fig 1 Teed Circuit

This circuit was constructed in the 1950s as a double 132KV overhead line using a ‘light’ construction on steel towers. Unexplained fault activity increased from 2006 and was found to originate on the Dunoon tee’d section. The terrain the tee traverses is wooded with hills and valleys with a long span crossing a loch. The maximum elevation is 370m. There are several sections close to the sea. A simplified line diagram of the complete circuit is shown in Figure 1 and one of the towers in Fig 2. The section lengths have been refined using traveling wave measurements over the past year.

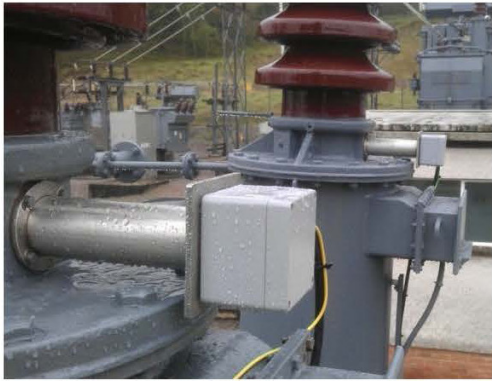
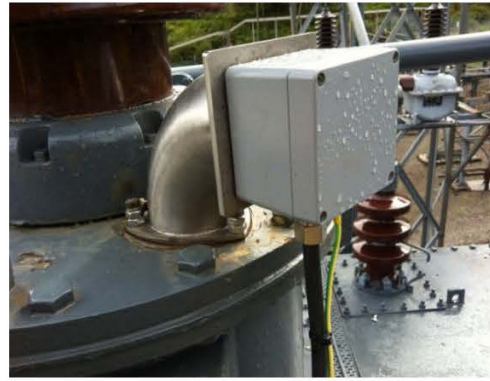
Fig 10 Adapters Fitted to the Bushing Taps to Allow TW Fault Location

Part of the SSE initiative to improve the circuit availability was to replace the current sensors at Dunoon with 'voltage' sensors in the form of couplers connected to the tapping points on the transformer HV bushings. These couplers, measuring the current to ground through the bushing capacitance as a result of the transient voltage, were fitted in September 2013 during line outages. Although the two 132/33KV transformers at Dunoon are identical there were two different types of bushing fitted meaning two different coupler designs had to be deployed. The couplers are shown in figure 10.

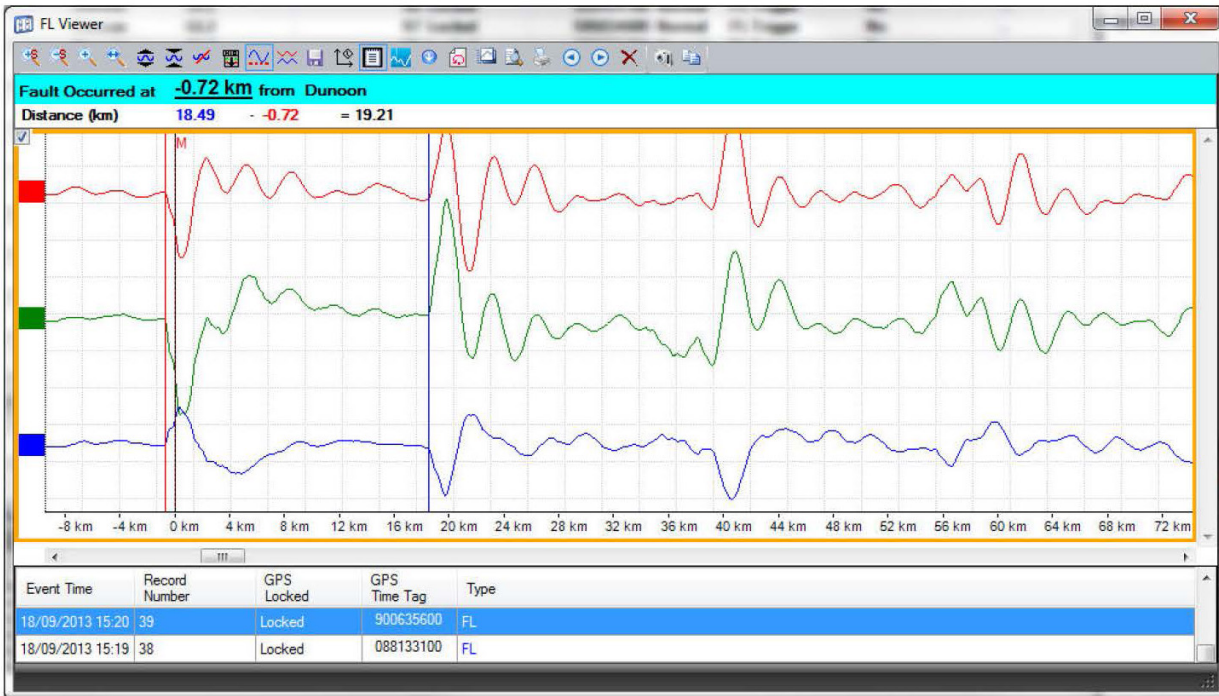
Fig 11 Energising GL2 from Windyhill

Figure 11 shows the waveform captured on 18th September 2013 from the TWS at Dunoon when the tee'd circuit was energised by closing the circuit breaker at Windyhill. After adjusting the trigger point the opposite polarity reflection from Whistlefield can be identified 19.21km from Dunoon proving correct operation of the bushing coupler assembly. Whistlefield produces a relatively large reflection because short underground cables are used to connect from the lines to the transformers creating a significant impedance change.
